# Preserving the Tower Clocks at Fort Monroe, Virginia

*Alan Bomar, VA*

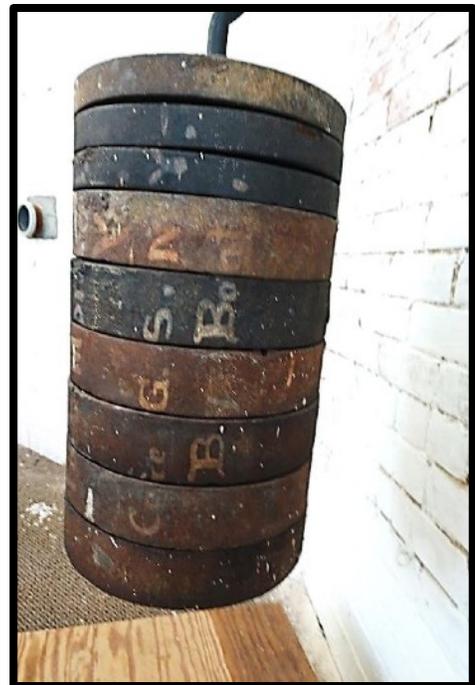
**Figure 4: Weight of the 1898 Seth Thomas tower clock in the Office building at Fort Monroe. Markings on the side reads *Thomas clock, W.S. P.O. Building Fort Monroe VA Care G.S.N.Y. By Boat.***

The weights are interesting in that they are painted with what appears to be delivery instructions. In the stacked configuration, the weights read “Seth Thomas U. S. Post Office Building, Fort Monroe VA. Care

G.S. N.Y. by Boat”.

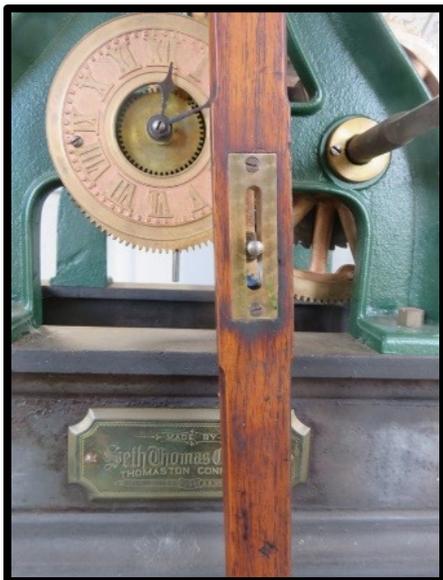
**Figure 5: Seth Thomas Model 5 pilot dial and pendulum rod crutch.**

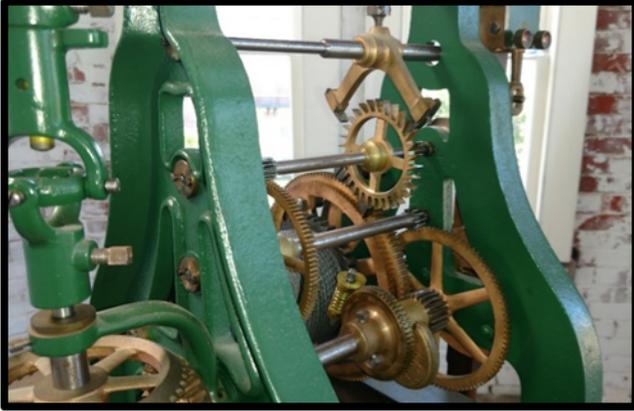
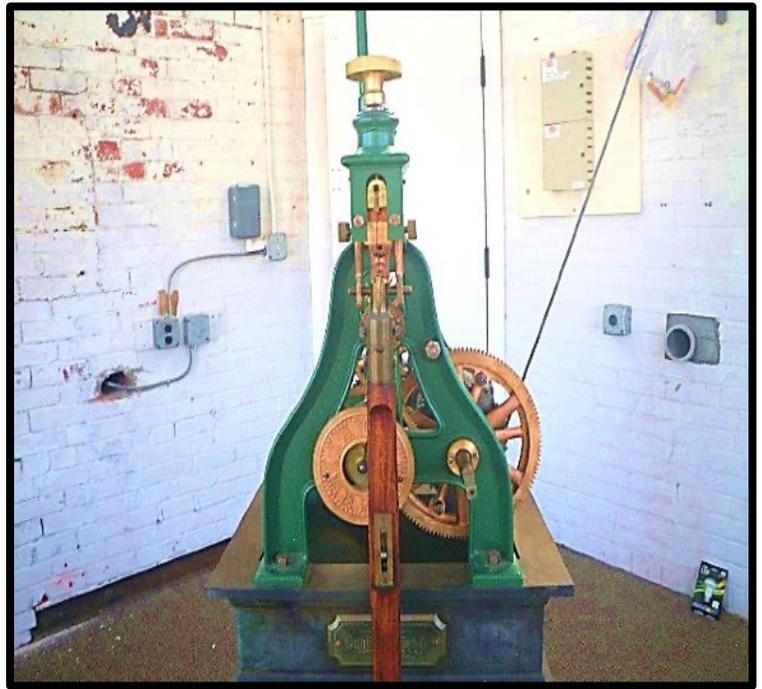
**Figures 6&7: Full view of the S.T. Model 5 movement in the Post Office Building tower, and close-up of the escapement.**

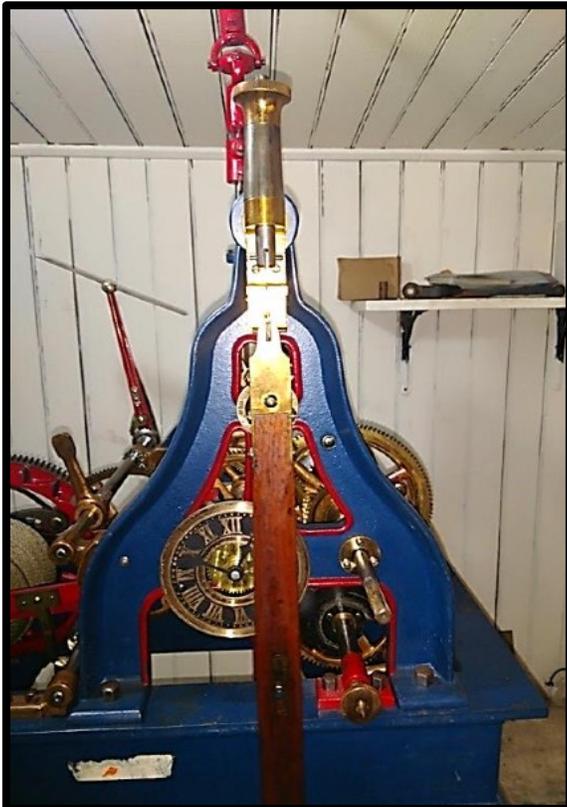
**Figure 10: (Left) Seth Thomas Model 15 Striker in the Main**

**Barracks Building at Fort Monroe. There is no label plate on the clock and the origin of the red and blue paint scheme**

is unknown.

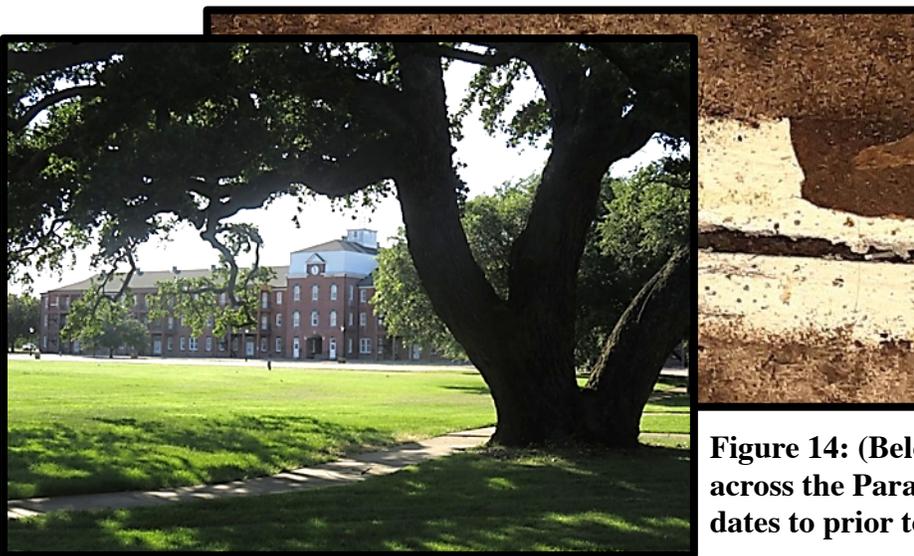
**Figure 13: Indentation in the floor of the clock room in the Main Barracks Building, possibly resulting from a broken pendulum suspension spring. The size of the dent is similar to the point on the pendulum rod.**

In 2019, evidence was discovered that the Model 15 striker pendulum spring may have previously been broken and repaired. When an old piece of tape was removed from the floor under the clock, an indentation that matches the size and diameter of the point of the pendulum was revealed.

This clock does not have the pendulum catch system found on the 1898 Model 5, so if the spring were to break, the pendulum would fall to the floor. Coincidentally, the 1880 record of the Model 15 Clock in the *Seth Thomas Order Books* also carries a related comment:

“Feb 15/97 – ordered new pend spring”, suggesting the spring had broken sixteen or so years after the clock was first put into service. We believe the dent in the floor represents evidence of the spring breaking.

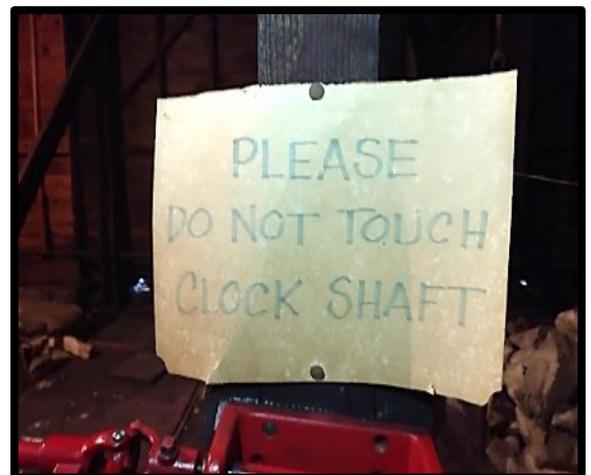
**Figure 16: “Classic” Army signage for the clock in the Main Barracks Building. The shaft is 40 feet long supported by two posts.**

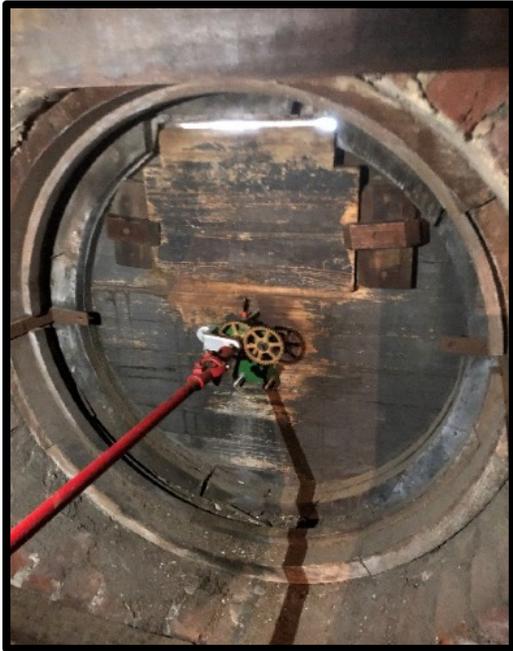
**Figure 17: Model 15 dial motion works on the rear of one of the four dials in the tower of the Main Barracks Building at Fort Monroe. Note the top-hinged dial access door – a nice arrangement!**
